**REPORT ON LOWER KACHURA LAKE AND POSSIBLE POLLUTION
SOURCES**

Date	5 th - 7 th August 2018.	
Purpose	To investigate the potential sources (point and non-point) deteriorating the water quality of Lower Kachura Lake	
Team	Khadim Hussain Syed Waqar Hussain	Assistant Director R&D Field Monitoring Assistant

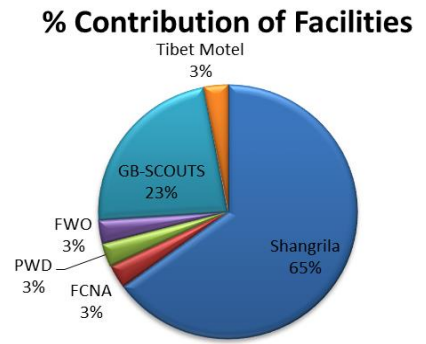
7. Percentage Pollution Load of Facilities on Lake

Following figure is developed on the basis of below mention factors:

- Covered Area
- Number of buildings
- Distance and Elevation from Lake
- Discharge of gray, brown and black water from Kitchen, Toilets and landscaping
- Surface Runoff
- Tourist influx and solid waste management
- Terrain

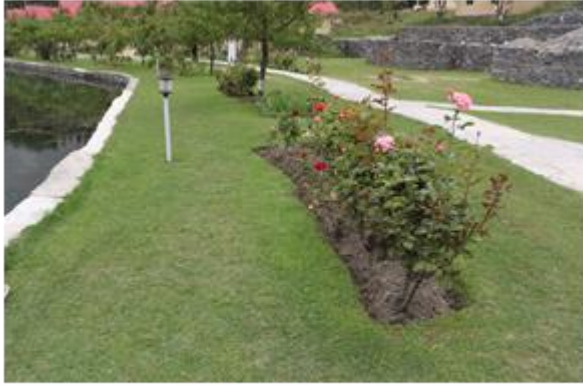
- i. Discharge of gray, brown and black water from Shangrila Resort and GB Scouts Rest House.
- ii. Surface runoff of landscaping water and/or rainwater along with fertilizers used by Shangrila Resort in flower beds and trees situated along the edge of the lake.

Figure 1: Shangrila; Flower beds and trees along the edge of Lake

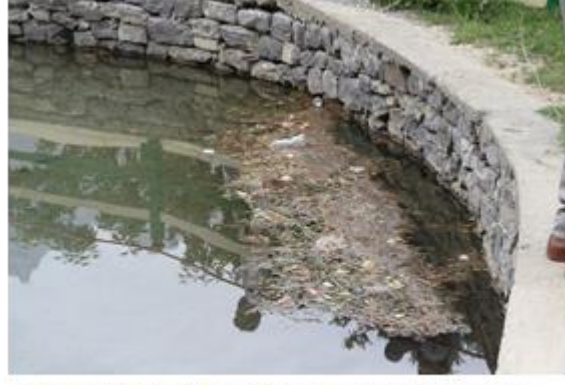
Most of the buildings of Shangrila Resort are situated very close to the lake and their elevation nearly equals to the lake water surface. Construction of soaking pits at this elevation leads to direct seepage of brown, gray and black water into the lake. During inspection overflow and seepage from Kitchen and latrines was observed. Empty mineral water bottles, juice packs and plastic bags were found along the circumference of lake occupied by Shangrila.

Figure 2: Shangrila; Empty bottles, plastic bags and wrappers

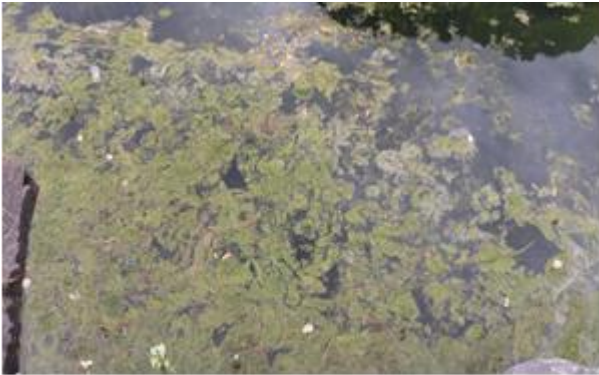
Eutrophication is the process in which lakes receive nutrients (nitrates, phosphate and potassium) and sediment from the surroundings and become more fertile and shallow. Human practices such as agriculture runoff, discharge of gray, brown and black water from kitchens, septic tanks and soak pits contain very concentrated amounts of nutrients. These nutrients wash into lakes during heavy rains or through direct seepage. The additional nutrients cause algal blooms which deteriorate the water quality and make it unfit for the survival of aquatic life. During the investigation excess amount of algal growth was observed in the lake; depleting the level of dissolve oxygen (DO), in Lake Ecosystem. Following are the main causes of eutrophication in the lake;

Figure 3: Shangrila; Massive Algal bloom in front of VIP suite

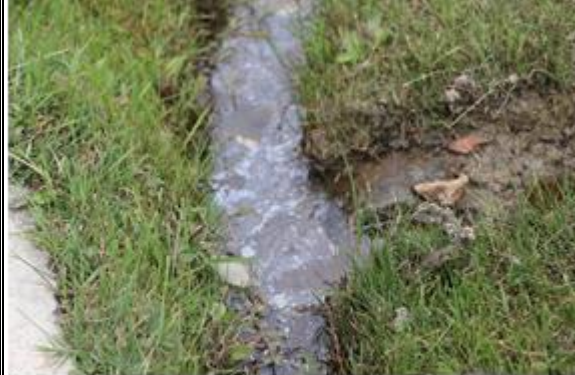
Figure 4: Shangrila; seeping water containing oil and grease in front of VIP suite

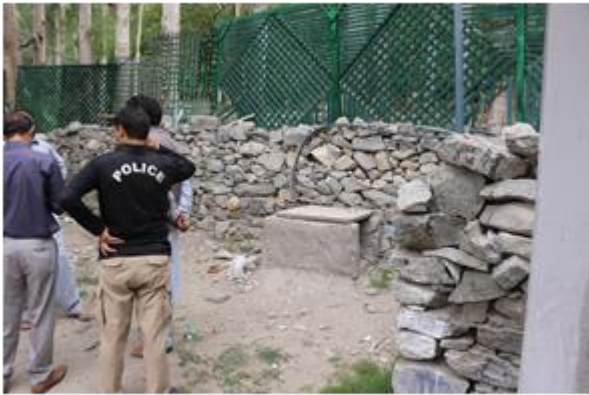
FCNA Rest House is situated adjacent to the Shangrila VIP suite. Sewerage system of FCNA is quite better and managed as compared to the others. Effluents from kitchen and washrooms are collected in a centralized septic tank (at a distance of 150 ft from lake) from where it is drained periodically using bowsers and being disposed off at a safe distance from lake, on an open land owned by FCNA.

Figure 5: FCNA; central septic tank

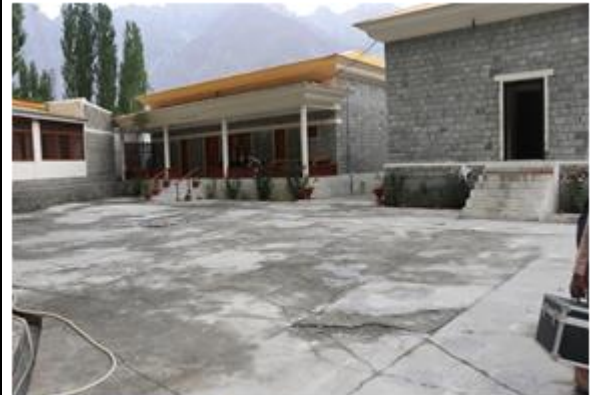
PWD VIP Rest House is located between FCNA and FWO Rest House. Safety tank and soak pits of PWD are situated at a distance of 400 ft and about 30 ft of elevation from lake. Effluents (gray, black and brown water) from Kitchen and washroom get enough time and space to be filtered before entering into the lake.

Figure 6: PWD; septic tank area

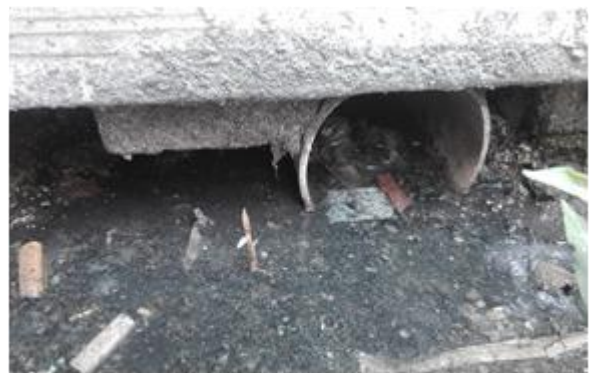
Figure 7: Sahngriila; kitchen drain directed towards Lake

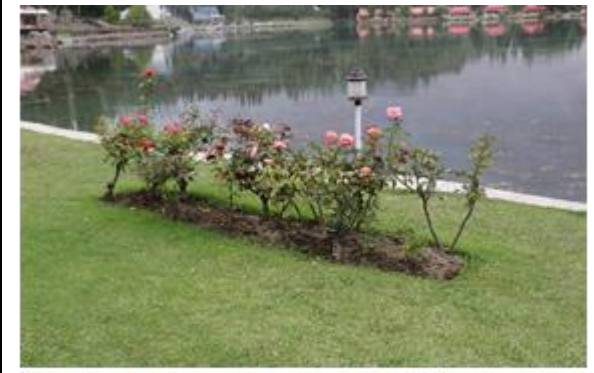
Figure 8: Shangriila; Flowerbeds Fertilized, potential pollution source

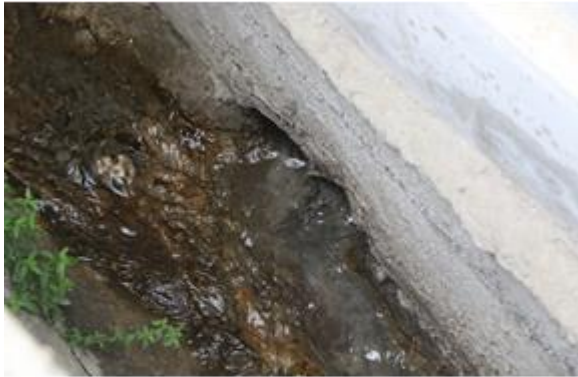
GB Scouts Rest House is situated next to PWD VIP Rest House. The sewerage system was not properly managed; septic tanks from rest rooms were over flowed and are seeped directly into lake. Effluents from Kitchen, washroom and open washing pad were directly discharged into water stream feeding the lake. Foul smell and discoloration of lake water at the inlet was observed.

Figure 9: GB-SCOUTS; kitchen and washroom effluent directly entering into water channel feeding the Lake

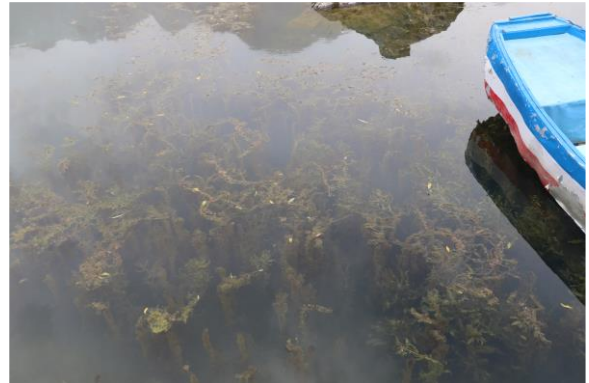
Figure 10: GB-SCOUTS; discoloration and eutrophication due to mixing of kitchen and washroom effluents

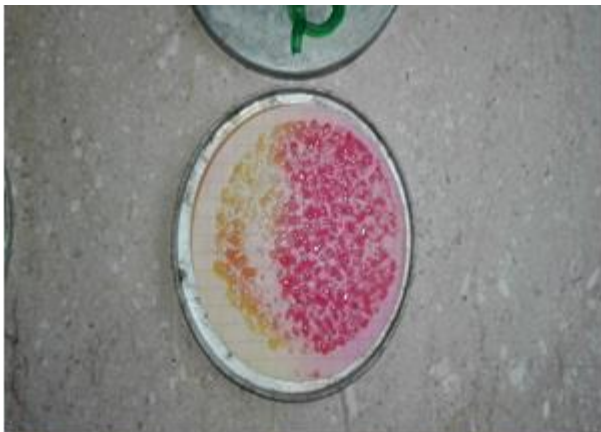
E. Coli is a gram negative non-spore forming bacilli (bacteria) which is found in warm blooded animal's feces and used as an indicator of water pollution for further investigation of other related organic pollutants. Water quality testing was carried out using **WAGTECH portable test kit**. Eight samples were collected adopting random sampling technique. Six samples were collected from lake and two samples from water channels feeding the lake. Out of eight samples six were found to be contaminated (samples taken from lake) while the rest of two (samples taken from channels) were uncontaminated. The results indicated that the water sources entering the lake are free of contamination which means the human activities around the lake i.e. discharge from kitchen and washrooms are the main sources of contamination.

Figure 11: Lake sample (infront of Shangrila): E.Coli TNT

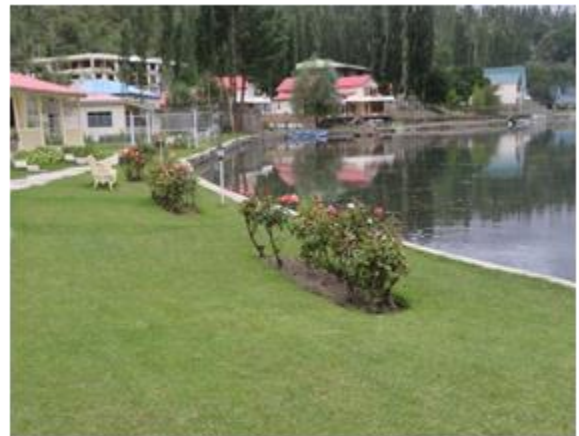
Natural water flows from the surface runoff and ground water discharge gets their natural path towards the lake, as it is lowest depression of the surrounding area. Hotels and rest houses throughout the circumference of the lake (sparing no free space) are situated at an elevation of 7,359 - 7,379 ft sloping towards the lake.

Figure 12: Shangrila: flowerbeds sloping towards Lake
